OBSERVATIONS ON AQUATIC MACROPHYTE DYNAMICS IN THE RESERVOIR OF THE BALBINA HYDROELECTRIC POWERPLANT, AMAZONAS STATE, BRAZIL

ABSTRACT — Between 1991 and 1995 aquatic macrophyte composition was observed in the lower part of the reservoir of the hydroelectric power plant of Balbina (Amazonas, Brazil). After closure of the dam in 1987, vegetation cover - mostly *Eichhornia crassipes* - was high, but was not quantified. After 1990 it declined rapidly with a characteristic succession pattern: *Eichhornia* → *Utricularia* + Cyperaceae → *Salvinia*. The Cyperaceae, and many other less dominant species, were mostly associated with drift wood, produced by the decomposing, emergent forest. Comparison of the chemical data of the Uatumã river before the construction of the dam (1983) with those of later years (1989 - 1995) suggests that the succession was the result of a relatively mild and short period of eutrophication, followed by declining nutrient levels. Annual variation of water levels, followed by aquatic and terrestrial decomposition of the marginal vegetation, may allow for the maintenance of relatively productive vegetation belts along the shore lines of islands and inundated strea

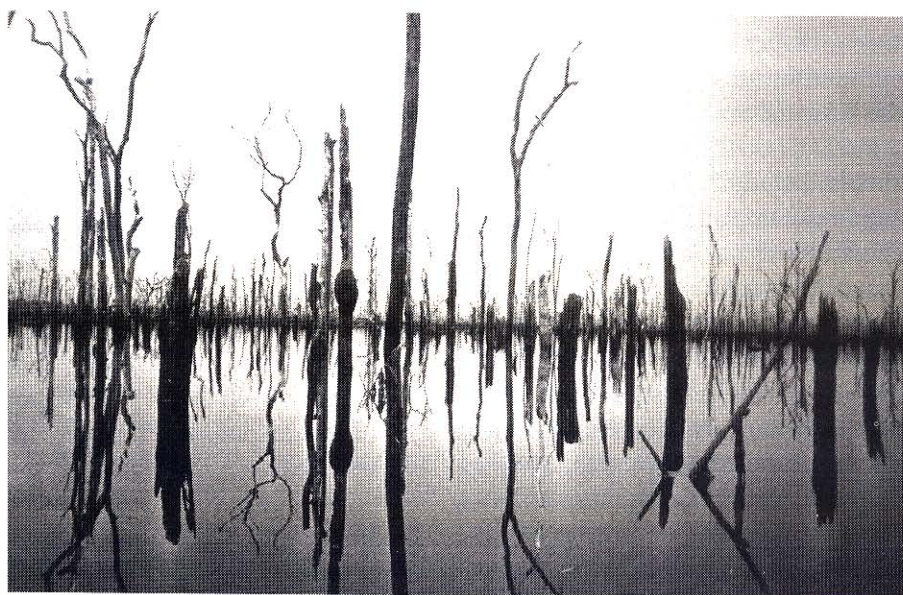
Figure 2. Dead forest during the low water period in September 1995. *Nasutitermes* sp. colony above the dark lower segment that marks the high water level.

broke off near the highwater mark. This zone is also preferred by the termites *Nasutitermes* sp.: of a total of 89 nests counted in September 1995 on standing trunks of 5-25 m height above the highwater mark, 43 were within 1 m above the mark. Also, several trees were noted with dense fungus belts just above this mark (Fig. 2).

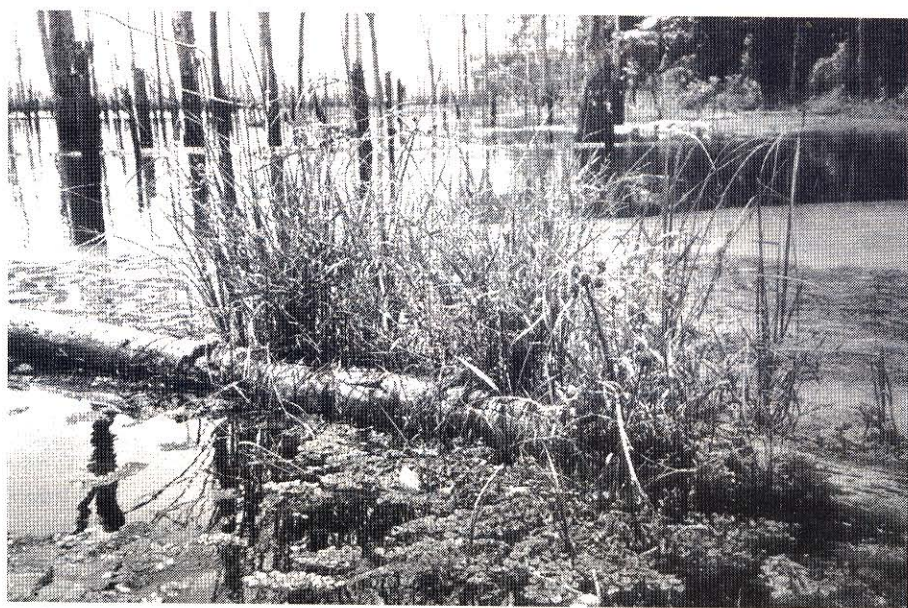
Figure 3. Floating trunk with vegetation and *Salvinia* in the vegetation belt of the Serra do Chocador island.

The vegetation colonizing drift wood. Decomposing logs drift on the water surface for months, if not for years, and they get colonized by a characteristic vegetation, (Fig. 3) which, when fully developed, may reach 40-80 cm in height. Examination of mostly bare trunks in Sept. 1995 showed that
